# Argonne National Laboratory

## INSPECTION, EVALUATION, AND OPERATION OF THE EBWR REACTOR VESSEL

November 1965

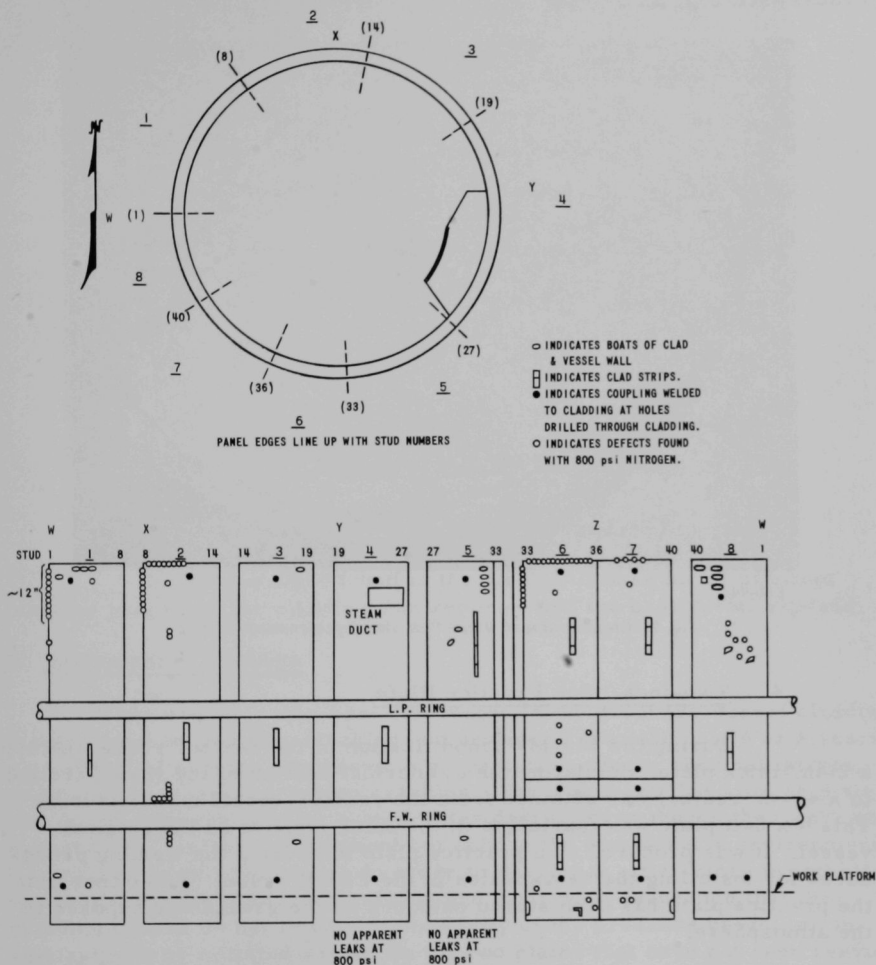
The upper course of the vessel is covered by eight vertical panels of cladding joined by longitudinal welds. Each panel is approximately 32 in. wide by 110 in. long. Five of the eight panels contained surface cracks. Over 75% of the cracks were in the vicinity of the steam zone and were clustered between the weld nuggets adjacent to the arc-deposited welds joining the panel sections (see Fig. 1).

Fig. 1. Orientation of Reactor-vessel Cladding Panels Showing Location of Boat and Strip Specimens

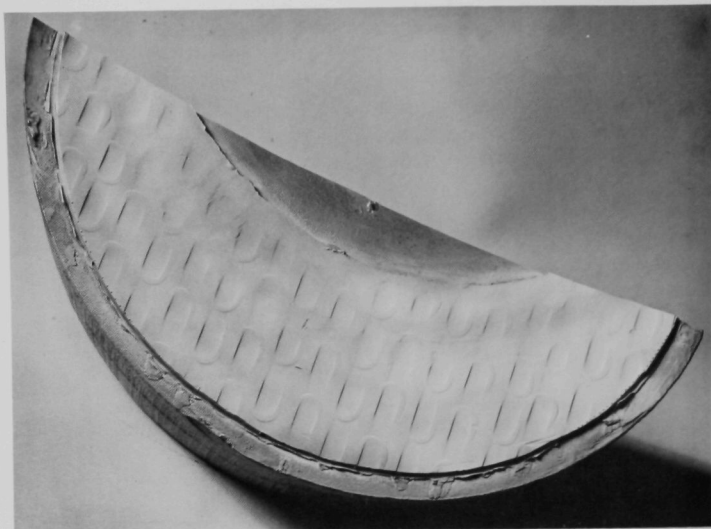
144-746

operation, was inspected during this period (1965). Dye-penetrant tests revealed that the surface of the cladding was free of cracks. The cladding on this plug was part of vessel panel No. 5 which was also free of surface cracks (see Fig. 2).

Fig. 2. Crescent-shaped Vessel Plug after Dye-penetrant Testing

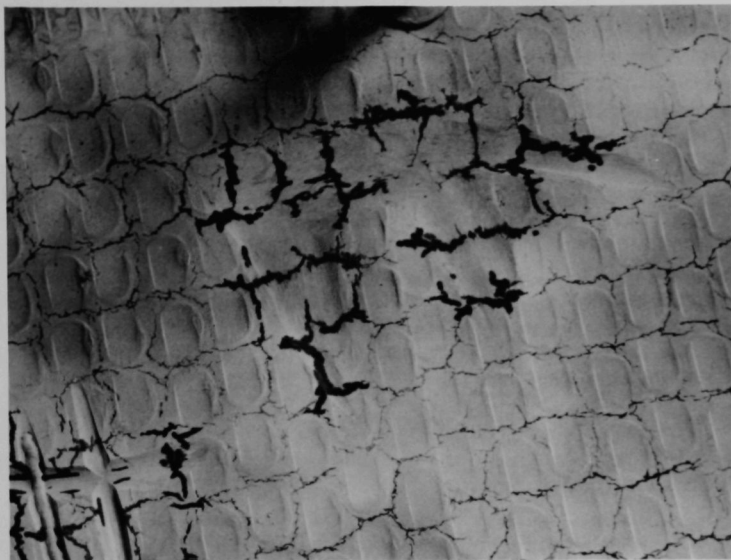
144-732

Dye-penetrant inspection revealed the clad surface on this plate to be more extensively cracked than the reactor vessel cladding, as shown in Fig. 3. In addition, attempts to perform practice welds on the cladding resulted in new crack formation and crack extension in the cladding.

Fig. 3. Two-inch-thick Practice Plate after Dye-penetrant Testing

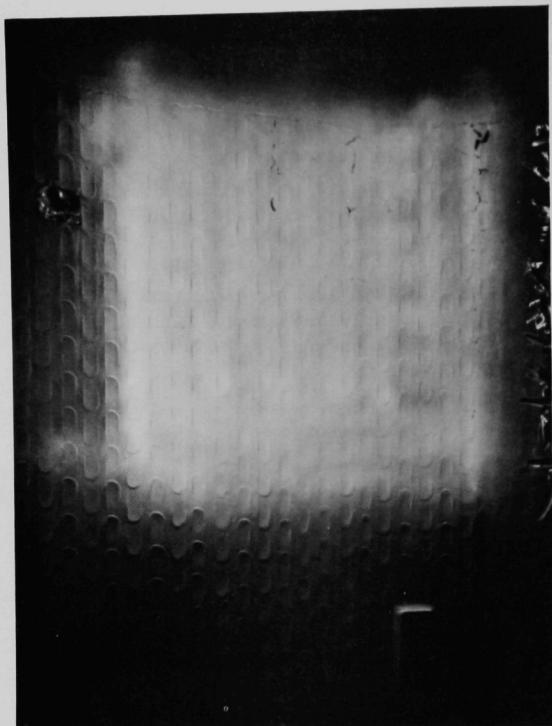
Almost all of the cracks followed paths between weld nuggets, as shown in Fig. 4 (thumb print). A few cracks, however, either ran across a "thumb print" or terminated in one.

Panel Showing "Thumb Prints"  
Characteristic of Method of  
Cladding, Dye-penetrant  
Indications of Cracking and  
Half-coupling Used in  
Pressure Testing

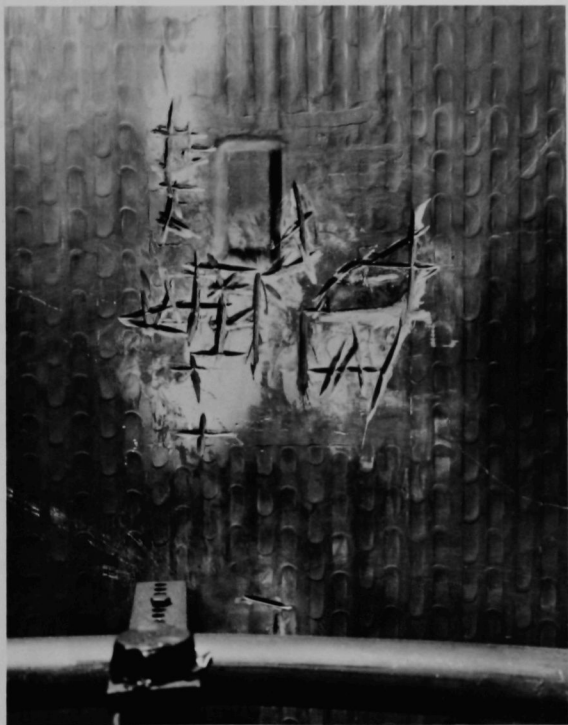
Fig. 5

A majority of the through cracks were ground out to the base metal with dye-penetrant inspections interspersed in the process to examine the character of the cracks through the cladding. The cracks appeared to increase in size and in number as the cladding was ground out, suggesting that the cracks may have originated at the interface between the cladding and the base metal. This was generally true for cracks that extended all the way through the cladding, but it cannot be definitely stated for all such cracks since it was found that many of the cladding cracks started at a point remote from the interface, such as at the weld nugget. It should be pointed out, however, that this characteristic of the cracks could also result from a changing stress pattern in the cladding as material was removed. Approximately 40 linear feet of cracks were ground out and examined in the above manner. The surface was carefully cleaned, and dye-penetrant testing was continued into the base metal (approximately 0.010 to 0.015 in. deep). No evidence of cracking of the base metal was found. There was also no evidence of parting in the resistance welds bonding the cladding to the vessel wall.

Appearance of the Panel Having  
Greatest Amount of Cladding  
Ground Away

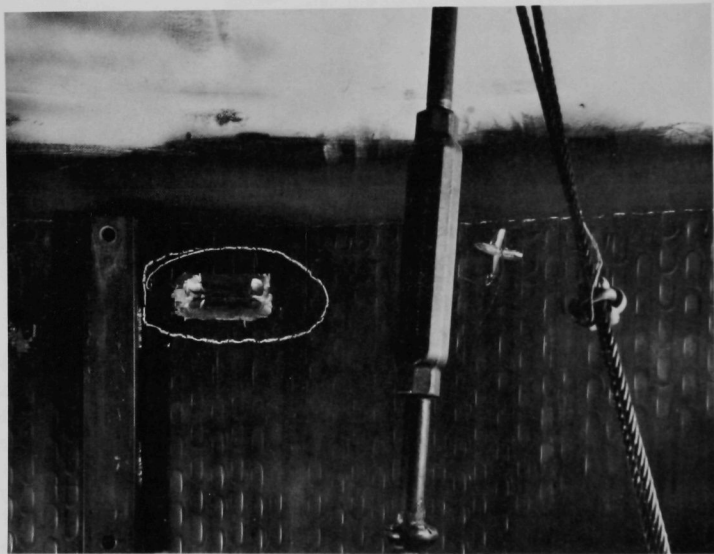
144-804

Boat samples, approximately  $1\frac{1}{2}$  in. wide by  $2\frac{1}{2}$  in. long (see Fig. 6) were cut from the upper portions of panels 1, 3, 5, and 8 to obtain representative samples of different degrees of cracking in the cladding. Panel 1 contained the most cracks, and panel 8 the least. Metallographic examinations were made on these boat samples. The results of these, as well as samples obtained from other supporting materials, are reported later.

Fig. 6. Typical Panel after Removal of Boat Sample

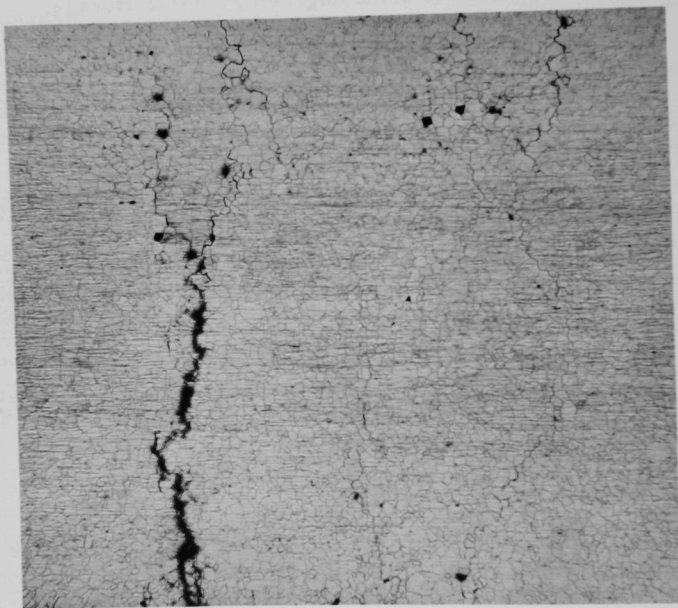
42285

(a) Through cracks, which were wider at the interface, appearing to originate at the interface (Fig. 7).

Fig. 7. Through Cracks Apparently Originating at the SA-212-B/Type 304 Stainless-steel Interface

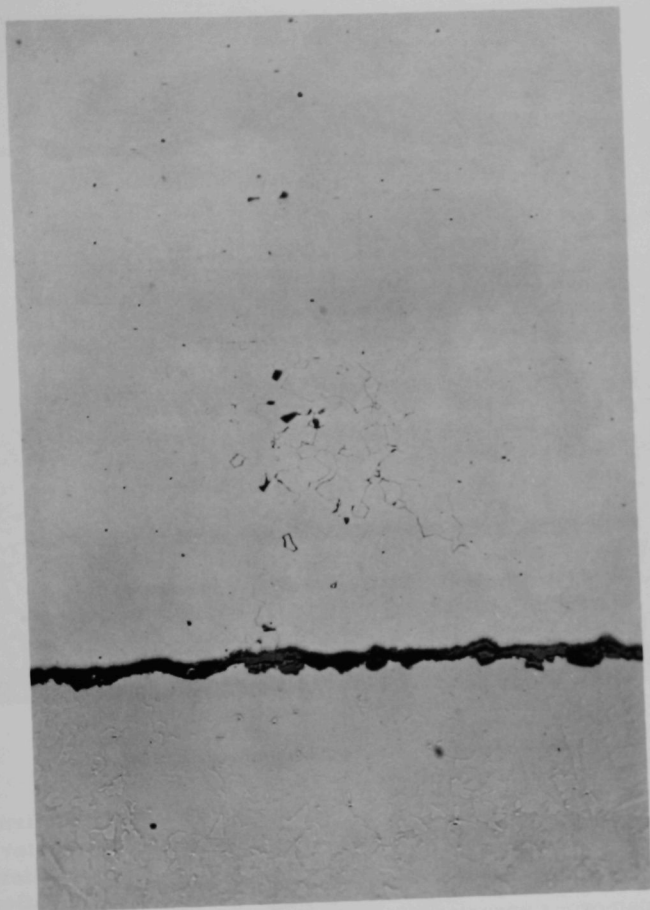
8636B

(b) Partially-developed and unsurfaced cracks, apparently unrelated to the presence of the through cracks (Fig. 8).

Fig. 8. Unsurfaced Cracks Apparently Unrelated to Through Cracks

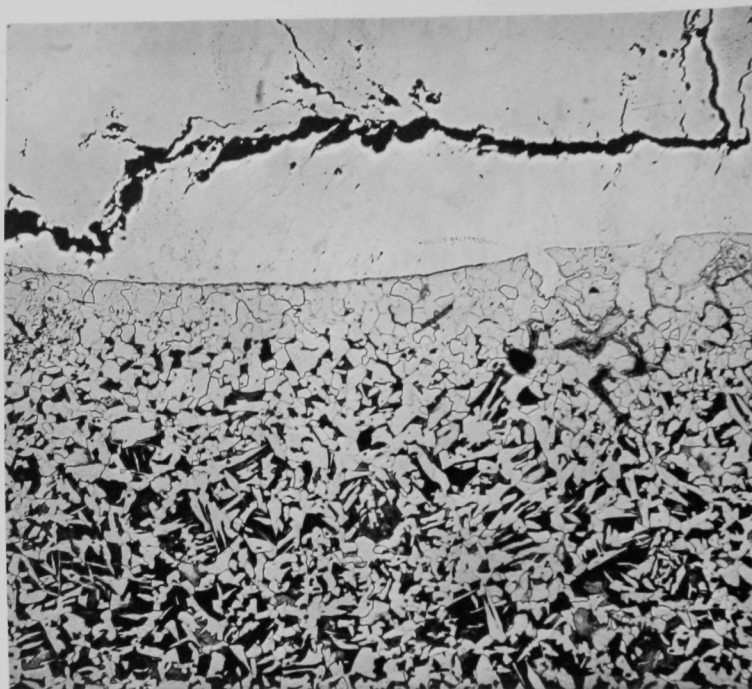
42077

(c) Lamellar cracks, paralleling the cladding surfaces in apparently homogeneous metal, as well as in regions containing inclusions (Fig. 9).

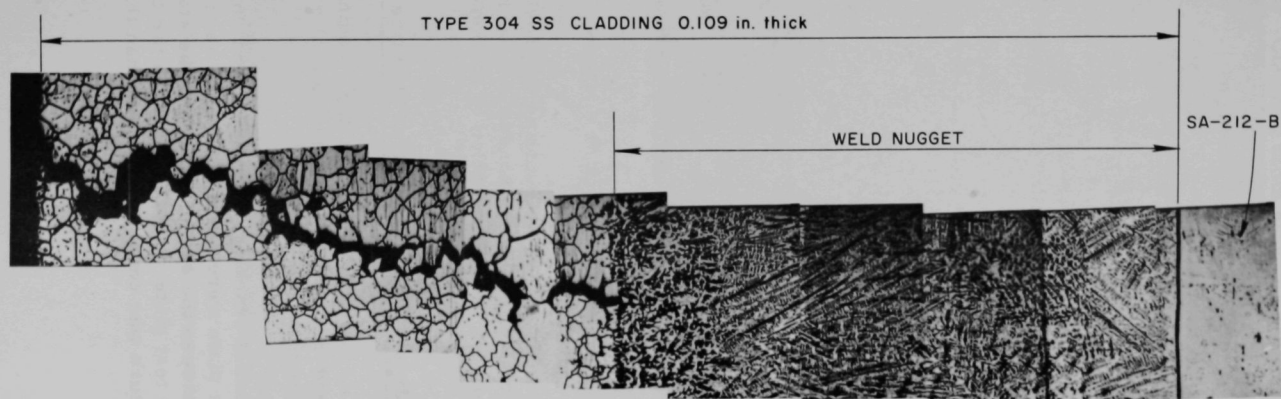
112-5050

Examinations of the cladding nuggets revealed a region of great complexity in both the stainless-steel cladding and SA-212-B materials (see Figs. 9 and 10). In all cases, only the SS 304 cladding material in the nugget area had been melted by the passage of welding current. All the nuggets contained a dendritic kernel which was originally wrought cladding. Kernels were islands of cast material bounded by wrought stainless steel, Type 304 cladding, and the SA-212-B steel. The wrought cladding surrounding the cast kernel contained numerous unsurfaced cracks radiating from the kernel interface, as shown in Fig. 11. These cracks, which are usually normal to the surface of the kernel, are primarily due to grain-boundary liquation.

Fig. 10. Arrest of Forced-crack Propagation by Weld Nugget due to Absence of Continuous Grain Boundaries

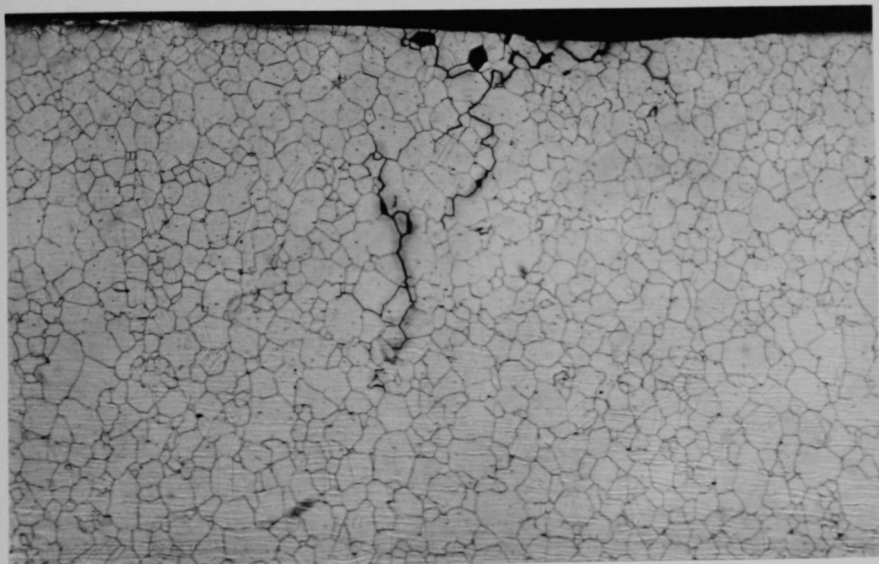
41929

(a) Cracks originating at the surface and partially propagated toward the interface (Fig. 12).

Fig. 12. Cracks Originating at the Type 304 Stainless-steel Surface

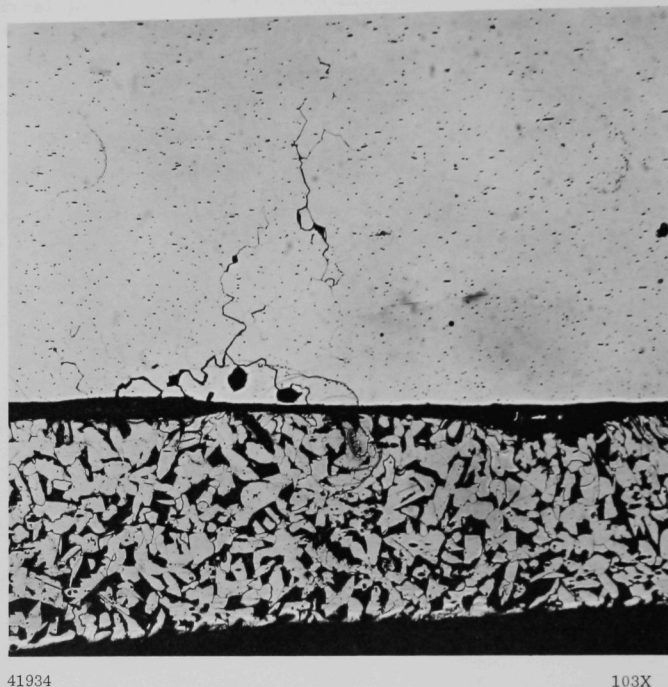
(b) Cracks originating at the interface and partially propagated toward the surface (Fig. 13).

Fig. 13. Cracks Originating at the Interface and Partially Propagated toward the Surface

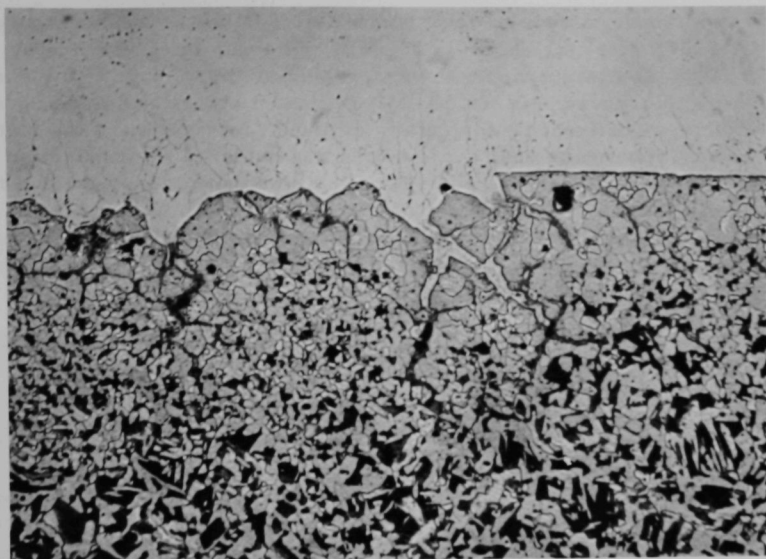
42078

Fig. 14. Microcracks in Surface of SA-212-B Plate (Note intrusion of Type 304 stainless steel)

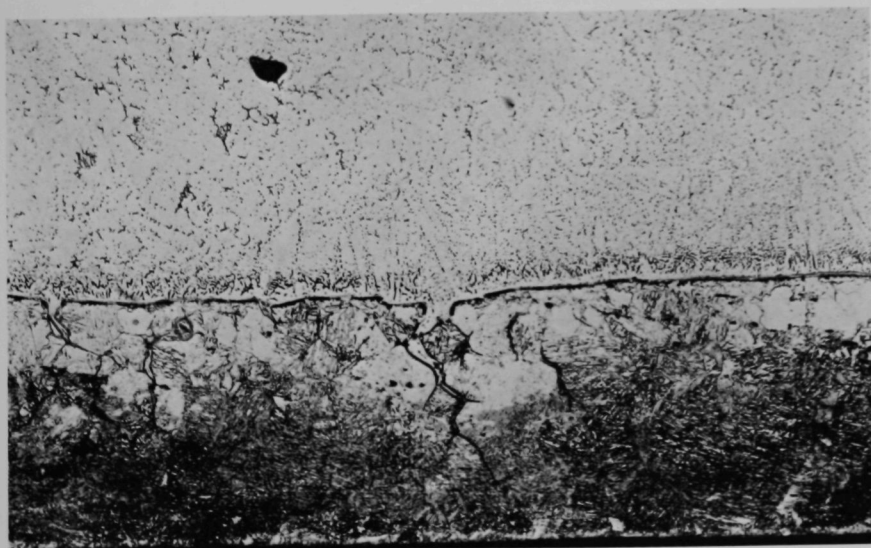
41935

Fig. 15. Intrusion of Type 304 Stainless Steel into Pre-existing Microcracks of SA-212-B Plate

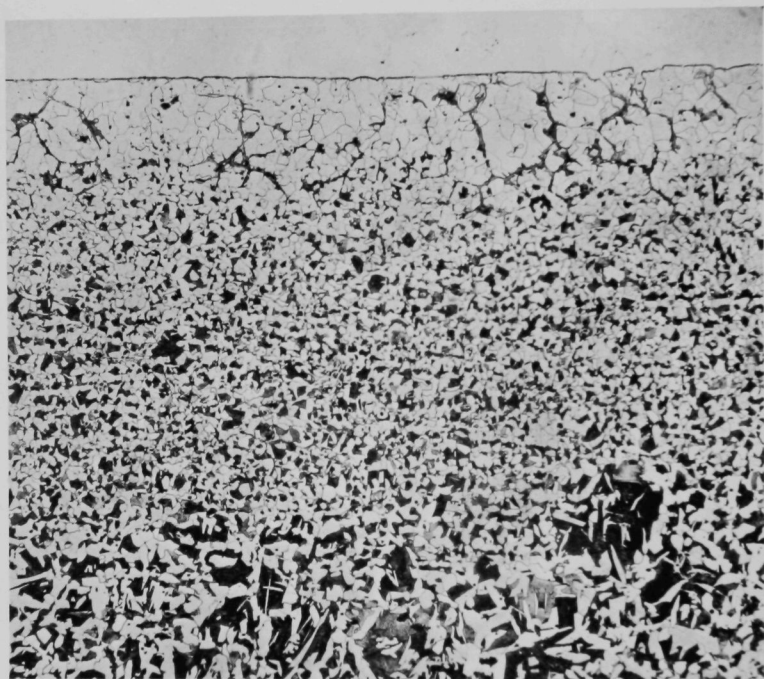
42079

were also found. A zone of decarburization, 0.010 in. max, was found in the SA-212-B steel, as shown in Fig. 16. This was later verified by microhardness examination. Metallographic studies conclusively showed that these microcracks in the SA-212-B existed before the cladding was applied and were probably formed in the initial fabrication of the plate. None of the specimens examined showed any evidence of propagation of the surface microcracks as a result of the cladding process, vessel fabrication, or reactor operation. Propagation of these microcracks is not expected in the future operations of the vessel, which will be operated at the same or lower pressure and temperature levels as in the past.

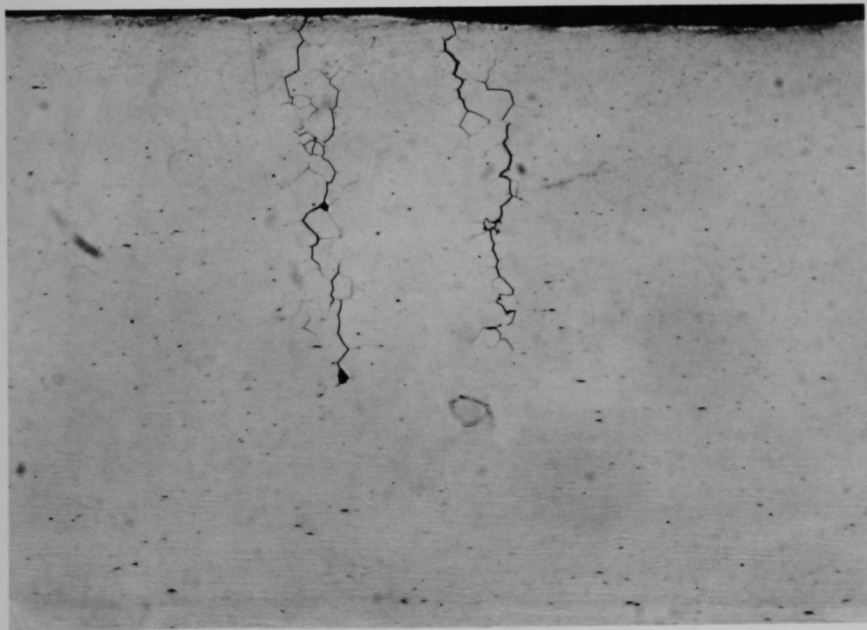
Fig. 17. Intergranular Cracking in Type 304 Stainless-steel Cladding

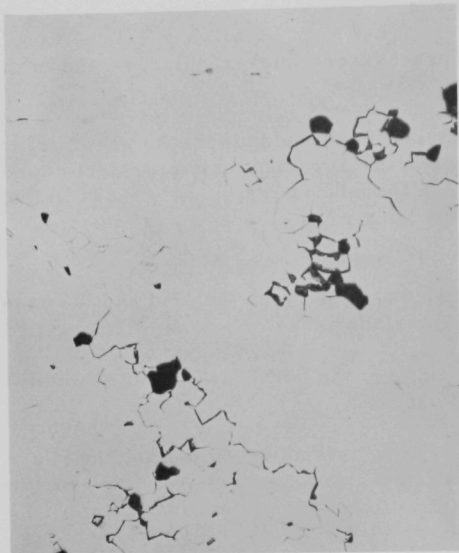
Fig. 18  
Intergranular Cracking in Type 304 Stainless-  
steel Cladding

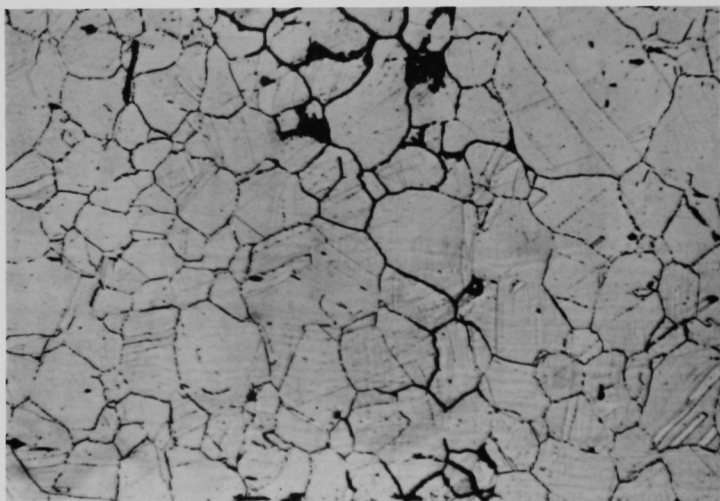
250X

(5) The wrought Type 304 stainless-steel cladding is sensitized. This occurred during the fabrication of the vessel. The equiaxed grains of the very fine-grained steel are prominently outlined by continuous networks of carbides, as shown in Fig. 19.

Fig. 19. Continuous Carbide Network in Type 304 Stainless Steel

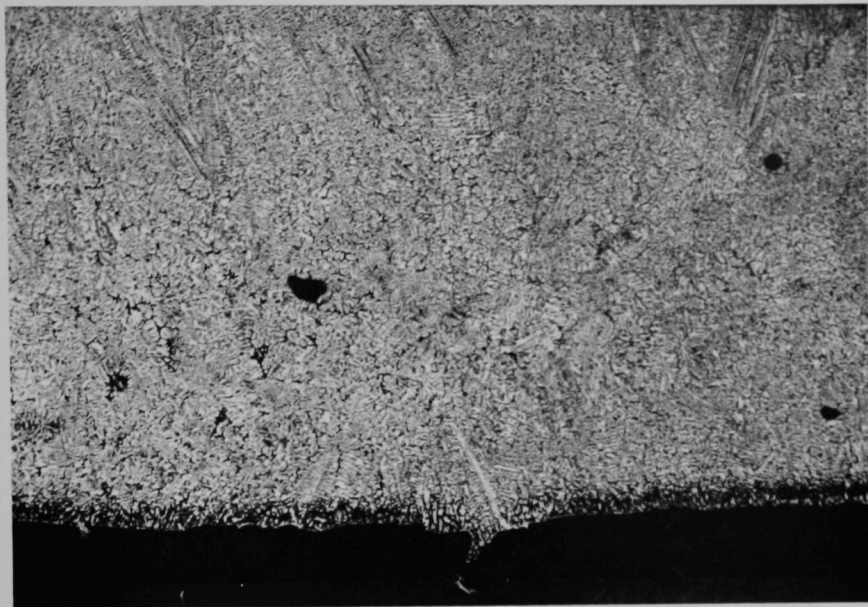
41928

(6) The fine dendritic structure of the kernel contains typical hot tears as well as rejected carbides, as shown in Fig. 20.

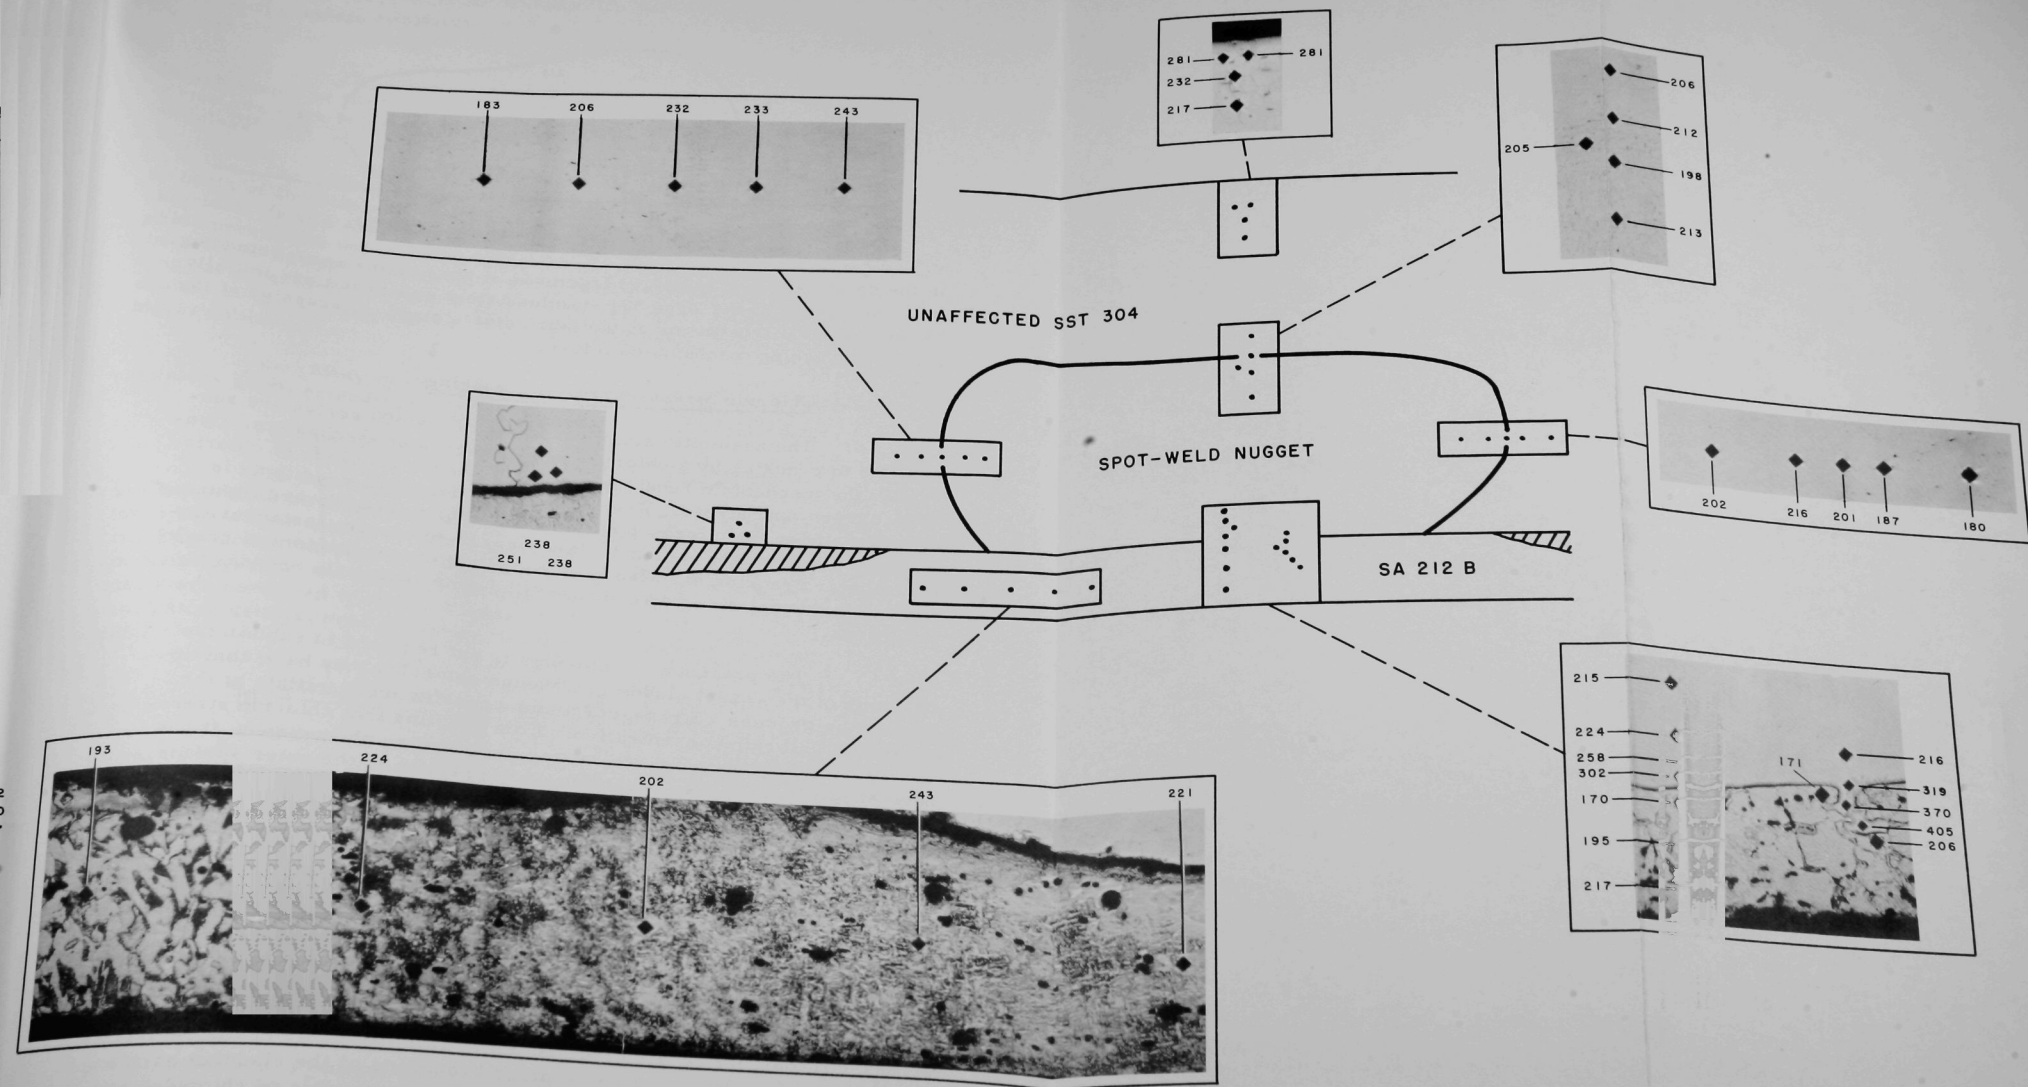
Fig. 24. Hardness Survey (DPH) of Boat Sample from Reactor Vessel. Note effect of carburization and decarburization, particularly at intrusions.
